# 418 Willow Creek Lane

Brookhaven, GA 30319 · Prepared for Jordan Ellis (sample)

Jamie Cole · WALKED Sample Inspector · SAMPLE-HI-0000 · sample@trywalked.com

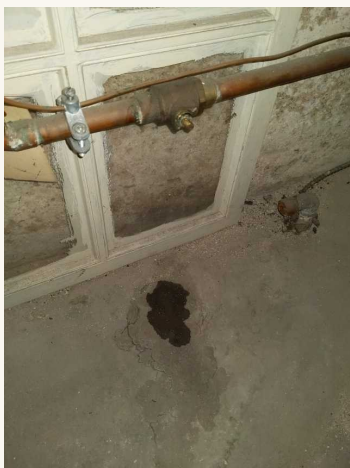
### Copper supply · active leak / puddle

Copper line over a wet spot on the floor — active plumbing leak. Hire a Pro.

Licensed plumber. Find the drip, repair the joint, dry the area.

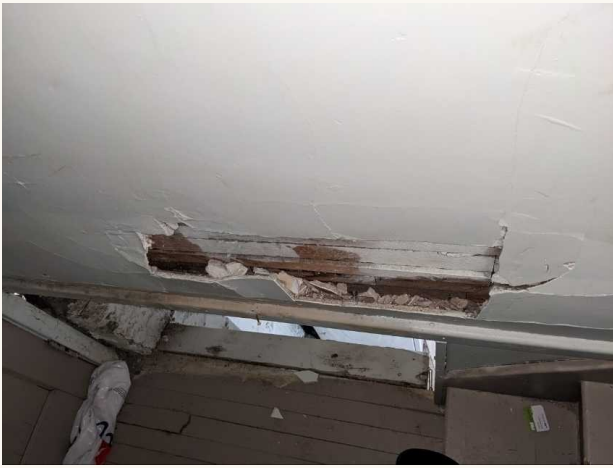
### Ceiling / soffit · water damage through lath

Plaster failed; stained lath shows behind it.  
Water damage — Hire a Pro.

Roofer / exterior carpenter. Trace the leak, then repair the ceiling.

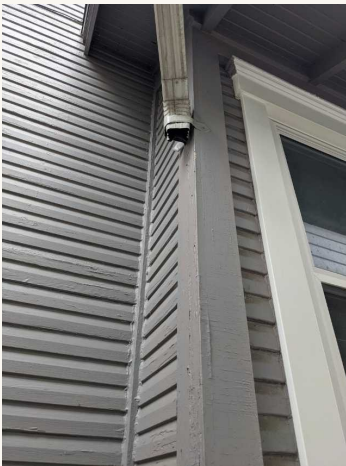
### Downspout · broken / disconnected at the eave

Downspout is open near the top — water dumps on the wall instead of the pipe.

Replace or re-secure the section; keep discharge off the foundation.

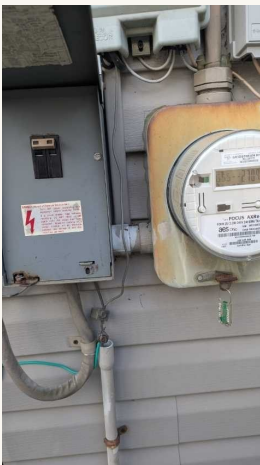
### Service entrance · meter / disconnect

Exterior meter and open disconnect photographed for the sample. Equipment note — not an interior panel.

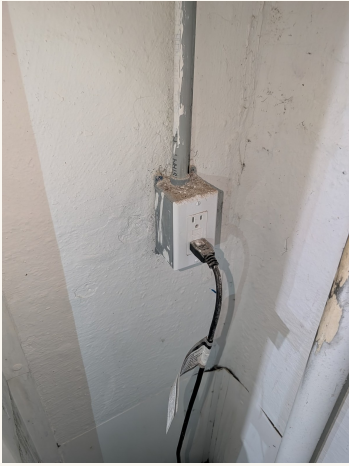
### Utility GFCI · surface box

GFCI in a surface box with conduit. Protection present.
