# 902 Meadowbrook Drive

Carmel, IN 46032 · Prepared for Sam Rivera (sample)

Jamie Cole · WALKED Sample Inspector · SAMPLE-HI-0000 · sample@trywalked.com

**Sample only.** Fictional address. Photos are representative field defect ammo with GPS/EXIF stripped — not an inspection of this address. WALKED does not sell inspector or client data. Independent — not PE / hedge-fund owned.

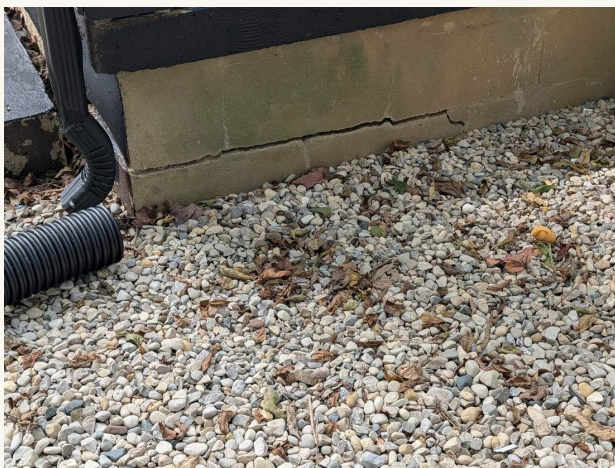
### Foundation · horizontal crack at downspout

Horizontal crack along the block course where the downspout lands. Hire a Pro — foundation.

Foundation / masonry. Evaluate the crack; keep water pulled away.

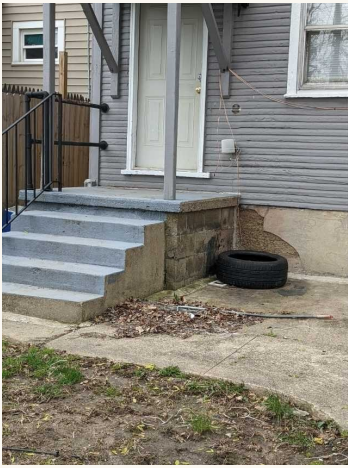
### Rear steps · parging failing at foundation

Parging is crumbling off the foundation beside the painted steps. Hire a Pro.

Mason / foundation. Repair coating; check for moisture behind it.

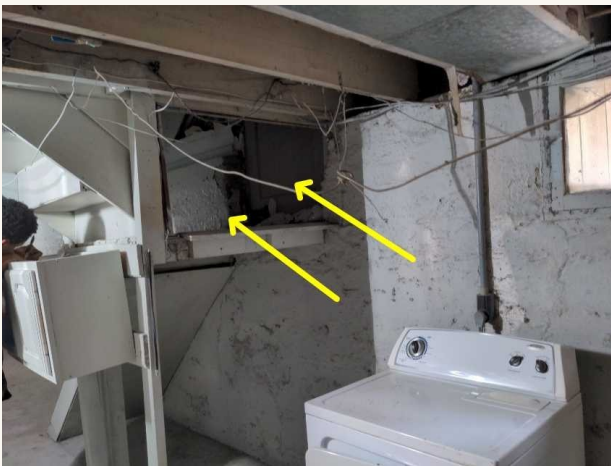
### Basement · open wall bay + hanging wiring

Open wall opening under the stair framing and loose wiring over laundry. Hire a Pro.

Licensed electrician. Secure and cover.

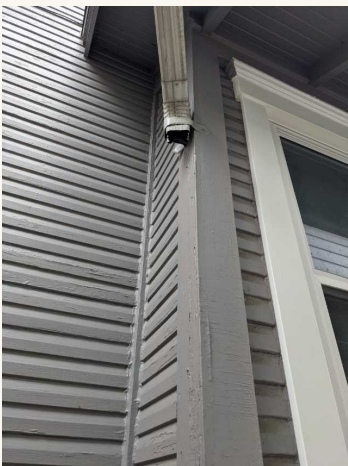
### Downspout · section broken off

Upper downspout is open — reconnect so water leaves the wall.

New section + straps; extend discharge away from the house.

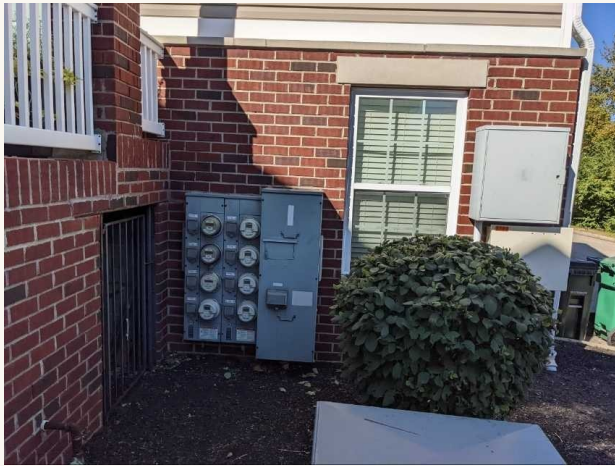
### Meter bank • clear the bush

Plant growth crowding the meters and service gear. Clearance is DIY.

Trim back; keep a clear working space at the meters.

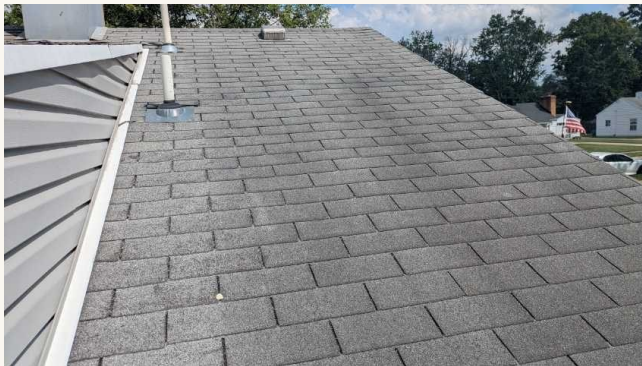
### Roof • aged three-tab / algae staining

Granule wear and dark algae streaks from the ladder walk. Age / budget note.

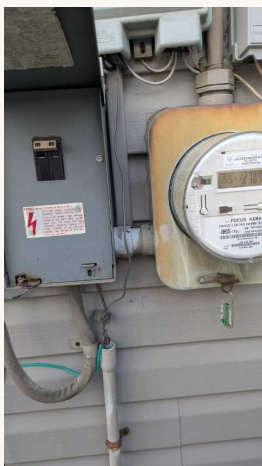
### Service entrance • meter / disconnect

Exterior service disconnect photographed with cover open. Equipment note.
